Brněnec project. Preservation of architectural surfaces. Concept # 1

Brněnec 3, 569 04 Brněnec, Czech Republic

Löw-Beer Factory, Schindler's Ark

Scientific advice: Ivo Hammer (on-site inspection together with Dr. Daniel Low-Beer,
Saturday, June 5, 2021)

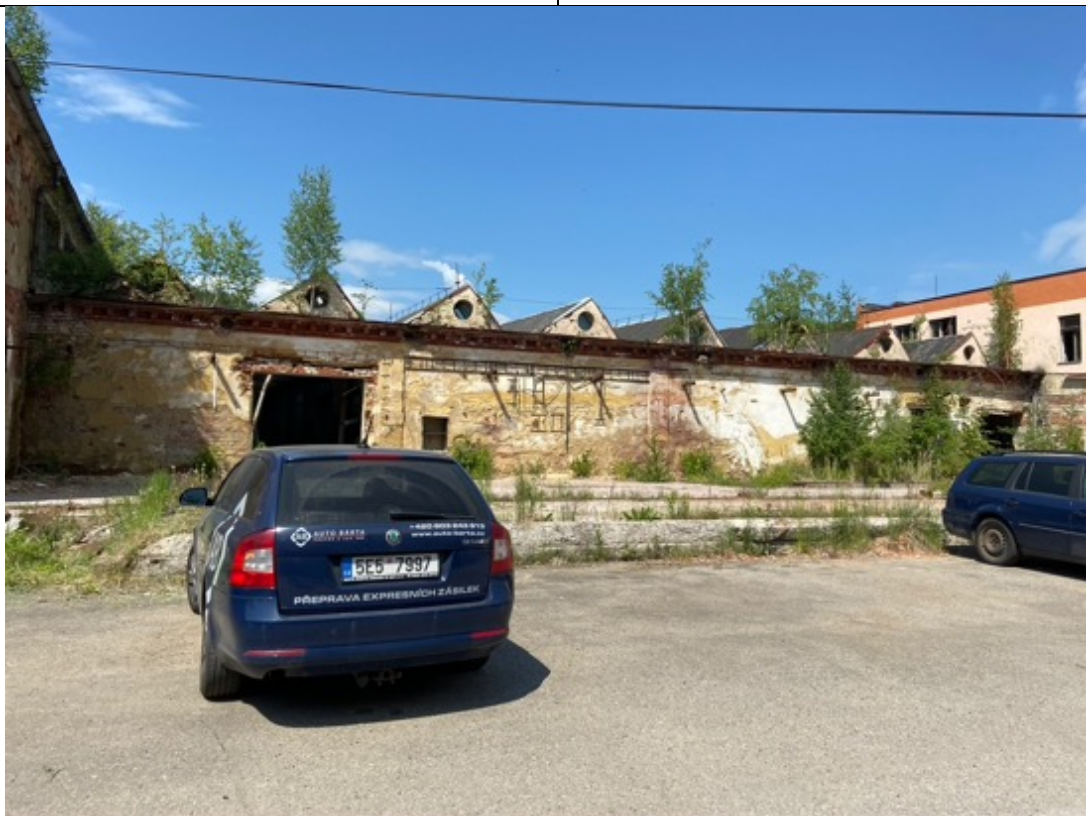
Spinning mill from approx. 1890, outer facade of the southernmost part, the later) vestibule has been removed; Structure of the smooth plastered façade with pilaster strips and serrated eaves made of brick, originally presumably yellowish-white lime paint, later several whitewashes in yellow and pink. The oculi of the hypetheral roof are bordered with fascia. The eaves of the roof gable may have originally only been protected with sheet metal. Photo: Ivo Hammer 2021

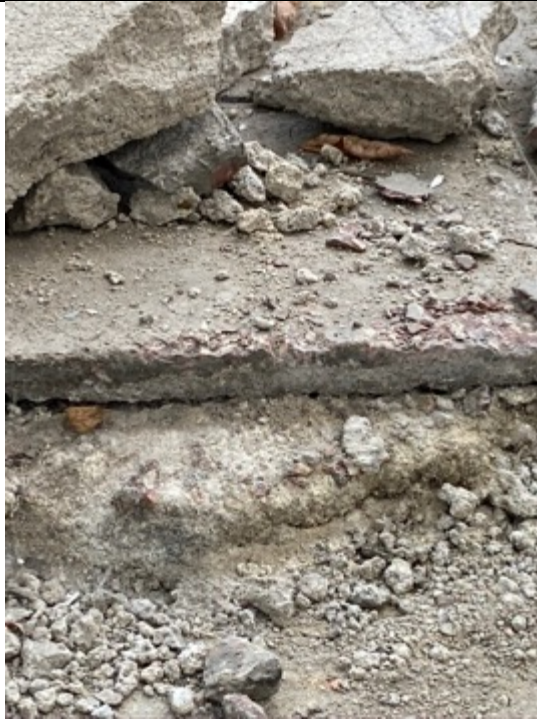
Spinning mill from approx. 1890, northern interior, broken edge of a machine pit: Under the destroyed recent concrete messenger, a possibly original slab of red terrazzo. Photo: Ivo Hammer 2021

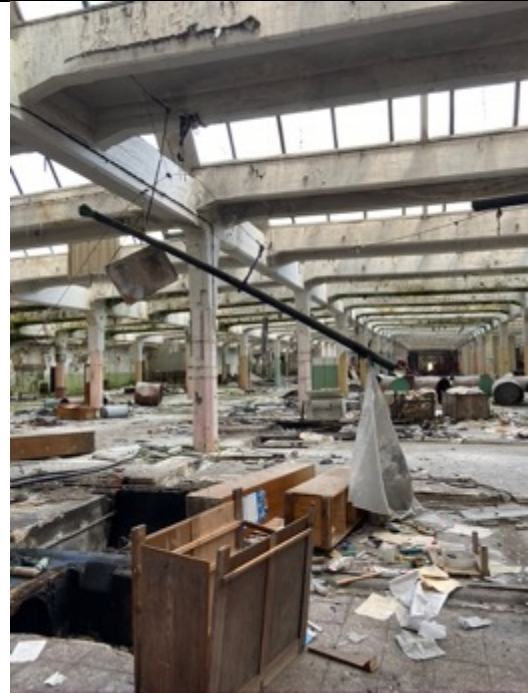
Spinning mill from approx. 1890, northern interior, machine pit and the rest of the heating pipes below the cross member. Photo: Ivo Hammer 2021

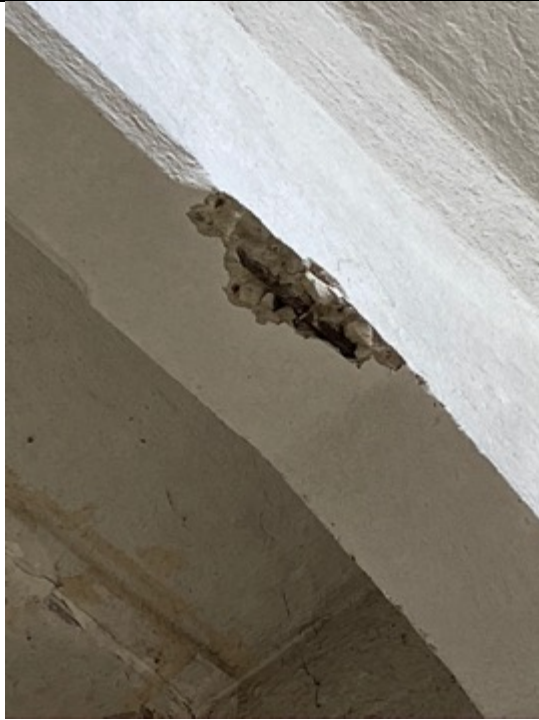
Spinning mill from approx. 1890, northern (?) Interior, detail of a cross member. The gray cement mortar and the reinforcing iron are visible in the mechanical damage.
Photo: Ivo Hammer 2021

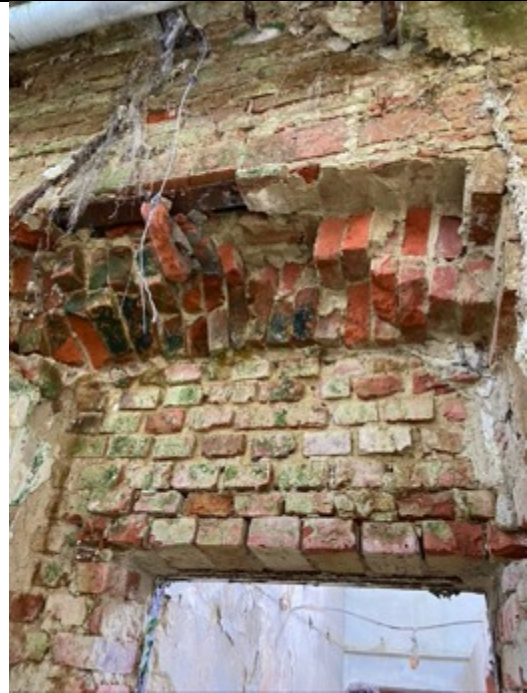
Spinning mill from around 1890, northern interior, east wall, detail. The brownish masonry mortar is visible on the broken-out segmental arch overlay of the door.
Photo: Ivo Hammer 2021

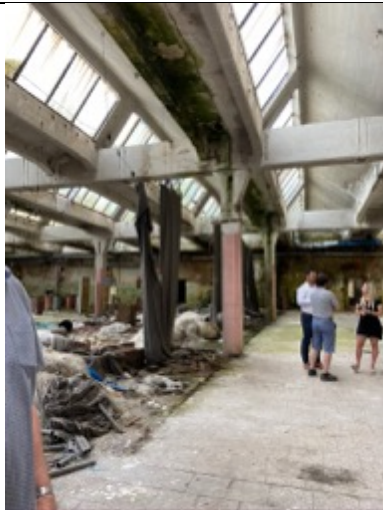
Spinning mill from approx. 1890, northern interior, joint between two yoke compartments in the side member and the cross member. In this area, the pillar is not monolithically connected to the girders.
Photo: Ivo Hammer 2021

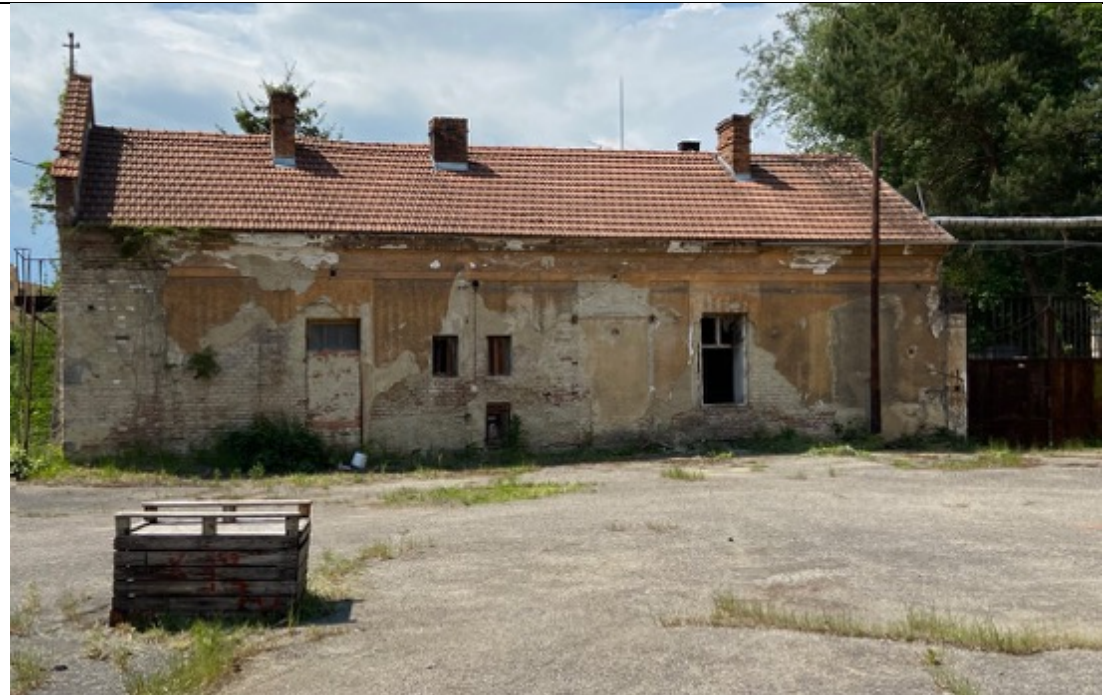
Residential building (management by Oskar and Emilie Schindler). Brick, block bond. Profiled eaves cornice. Raised south gable. 3 (?) Chimneys. Walled up doors. A window walled up with cement mortar. Photos: Ivo Hammer 2021

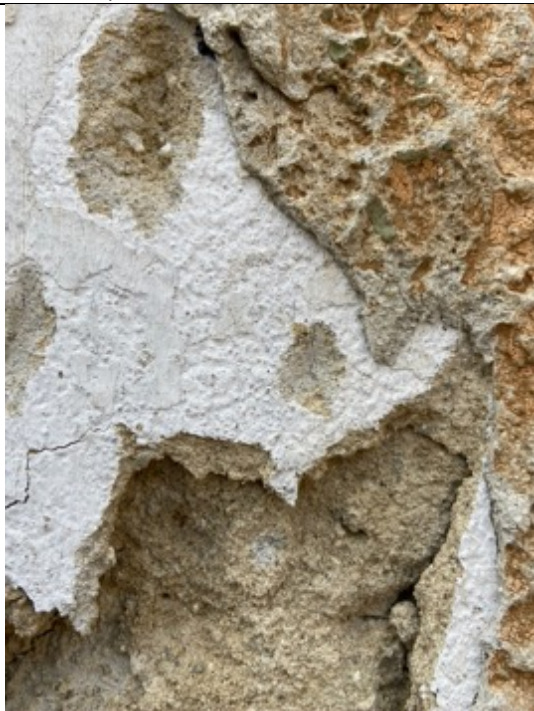
Residential building (management by Oskar and Emilie Schindler), facade detail: base plaster with yellowish-gray mortar with fine lime sparrows (dry slaking), fine plaster with the same mortar, only finer grain size.

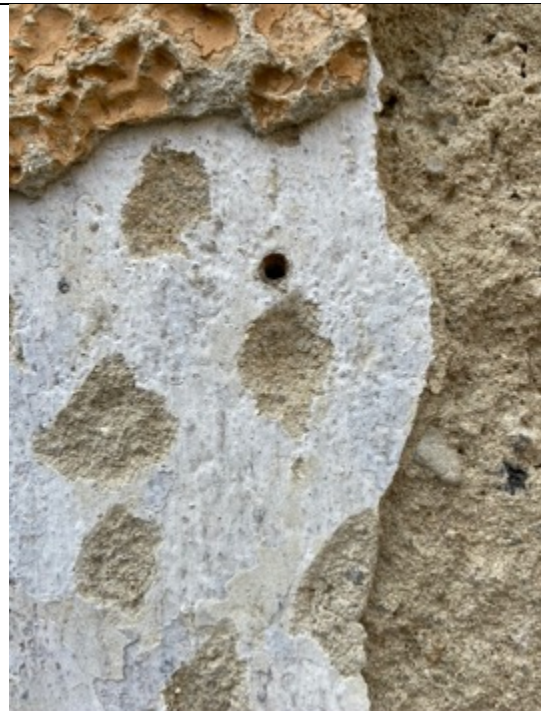
Rubbed surface, very light yellowish-white, thin Freko whitewash. 2 thin yellowish-white whitewashes. Stubby plaster with light gray mortar with fine lime sparrows, possibly natural plaster 3 whitewashes: brown, light red-brown, green. Photos: Ivo Hammer 2021

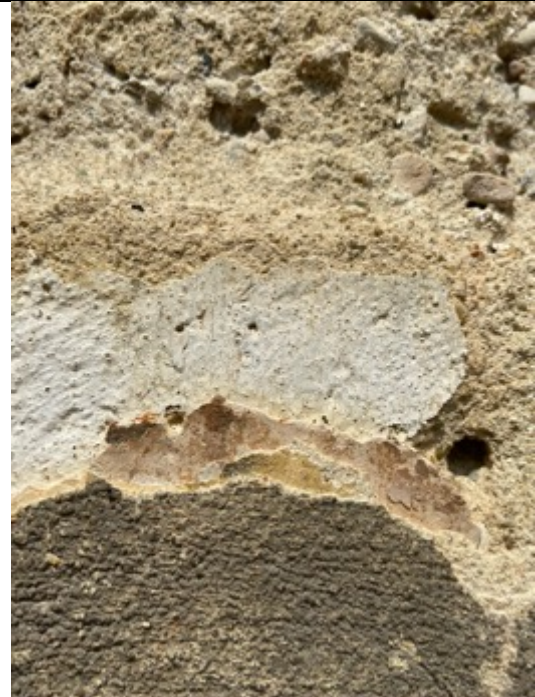
Former laboratory and workshop (SS-Bau des KZ Brnenec, German building). Details of the south facade (lower edge of the picture approx. 10 cm). Base plaster with yellowish-gray mortar with fine lime sparrows (dry slaking),

Fine plaster with the same mortar, only finer grain. Rubbed surface, very light yellowish-white, thin Freko whitewash. Approx. 5 whitewashes. Recent rub from (lime) mortar.

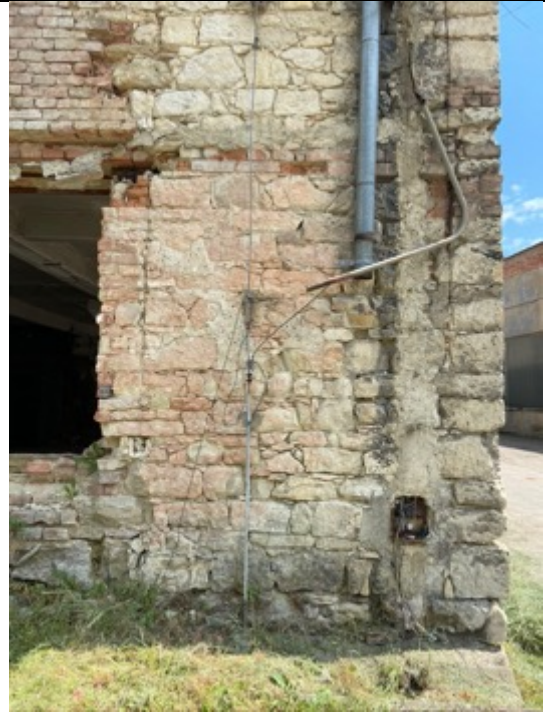
Local pink discoloration of the stone from the source of the fire.

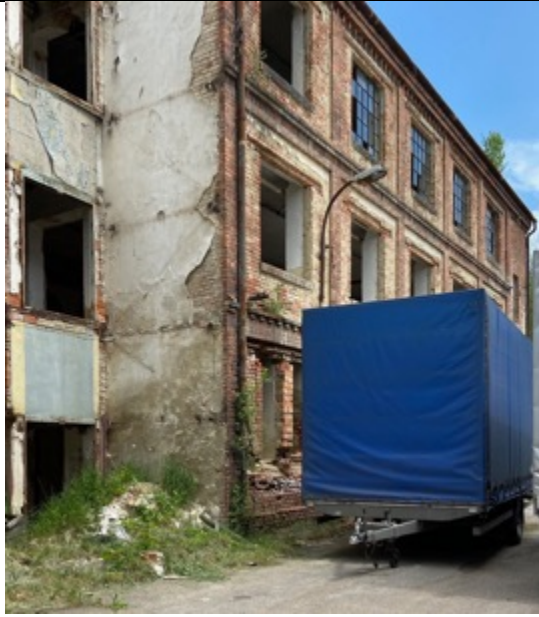
Right: (partially covered by a trailer) annex to the dye works: bricks, irregular structure, facade structure with pilaster strips, belt cornices with serrations and profiled eaves cornice. Flat roof. Lined window lintels made of double T-beams, cantilevered sills made of a group of bricks. The zero surface plastered smooth and whitewashed yellowish, the structure brick-faced (or red)? On the west wall of the Anex building, traces of a former external staircase (?), Which correspond in height to the adjoining wall openings, with smooth, yellowish-white plaster (damaged at the corners).

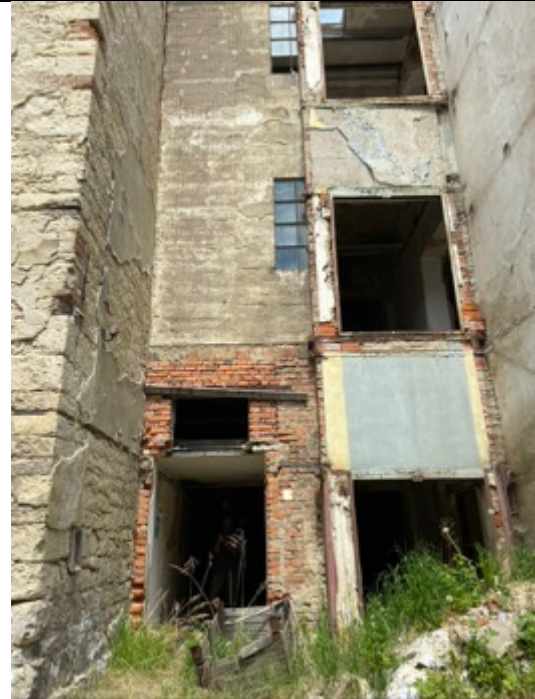
Between Schindler's Ark and the annex building of the dye works. On the right the structure possibly corresponding to the adjoining external staircase: steel girders with brickwork, HERAKLITH panels (wood wool with Sorel cement), plastered and leftover paint: yellow, gray (probably organic binder) and yellowish-white (lime) whitewash.

On the left on the ground floor a very irregular brick structure, the door opening has a lintel from a steel beam. Above a window opening with wooden elements. Above the brick structure, the roughly paved concrete wall of a stairwell with side windows. Traces of yellowish white whitewash and remnants of a smoothed (?) (Cement) plaster without whitewash.

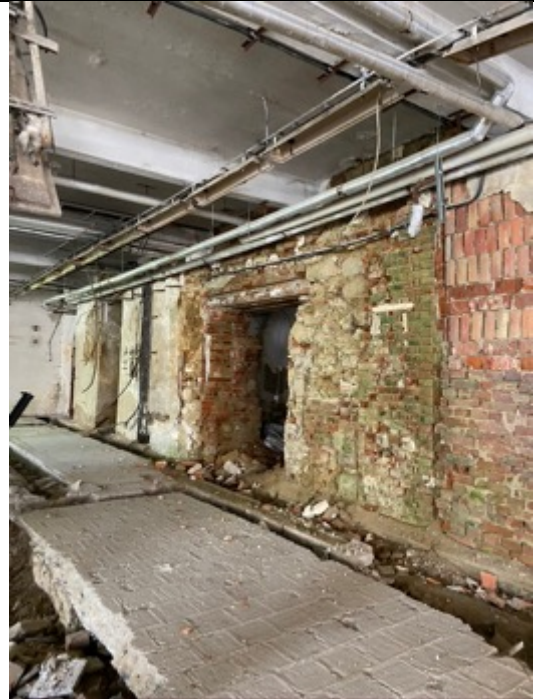
Schindler's Ark, ground floor, reinforced concrete hall, view to the northeast. Breakthrough through stone and brick wall. Bricking up a window. Photos: Ivo Hammer 2021

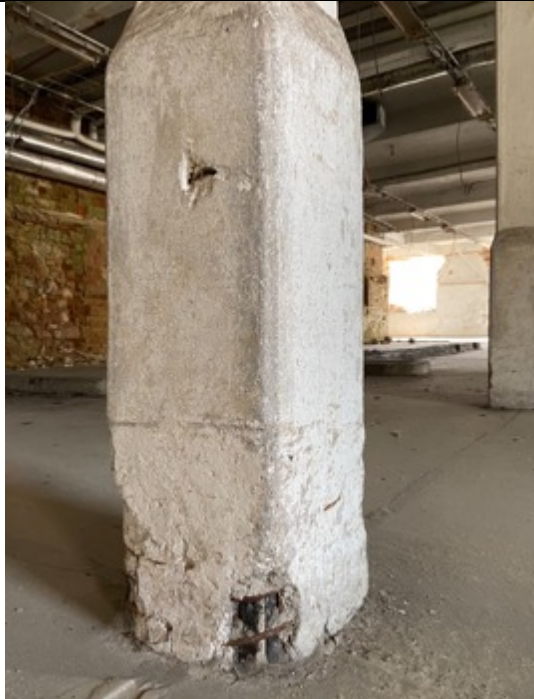
Schindler's Ark, 2nd floor, reinforced concrete hall, view to the southeast, detail: reinforcement of the pillar with reinforced concrete. Photos: Ivo Hammer 2021

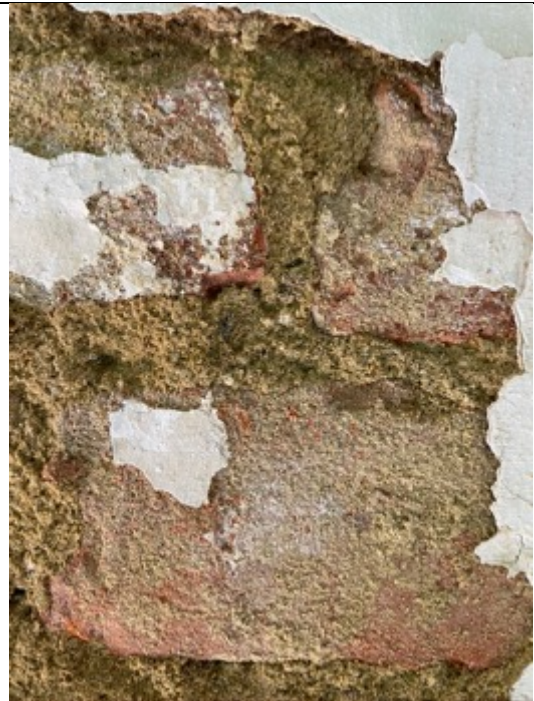
Schindler's Ark, 2nd floor, reinforced concrete hall, northern annex room, view to the south, detail: bricks, brownish masonry mortar, yellowish white lime whitewashes. 1-2 later whitewashes. Photo: Ivo Hammer 2021
