Brněnec project. Preservation of architectural surfaces. Concept # 1

Brněnec 3, 569 04 Brněnec, Czech Republic

Löw-Beer Factory, Schindler's Ark

Scientific advice: Ivo Hammer (on-site inspection together with Dr. Daniel Low-Beer,
Saturday, June 5, 2021)

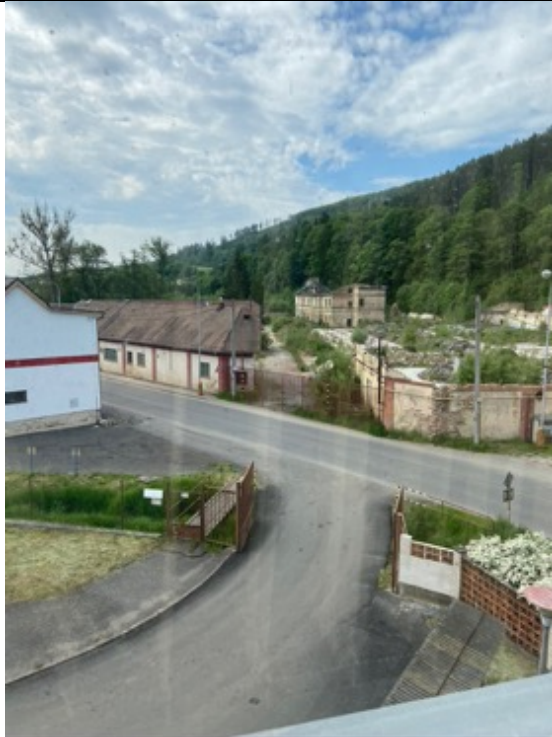
The largely destroyed southern part of the factory site: right. Remains of the surrounding wall of the weaving mill, in the middle in the background: partially destroyed dye works (warehouse for finished products), left. Garages; all left The renewed fire station. Photo: Ivo Hammer 2021

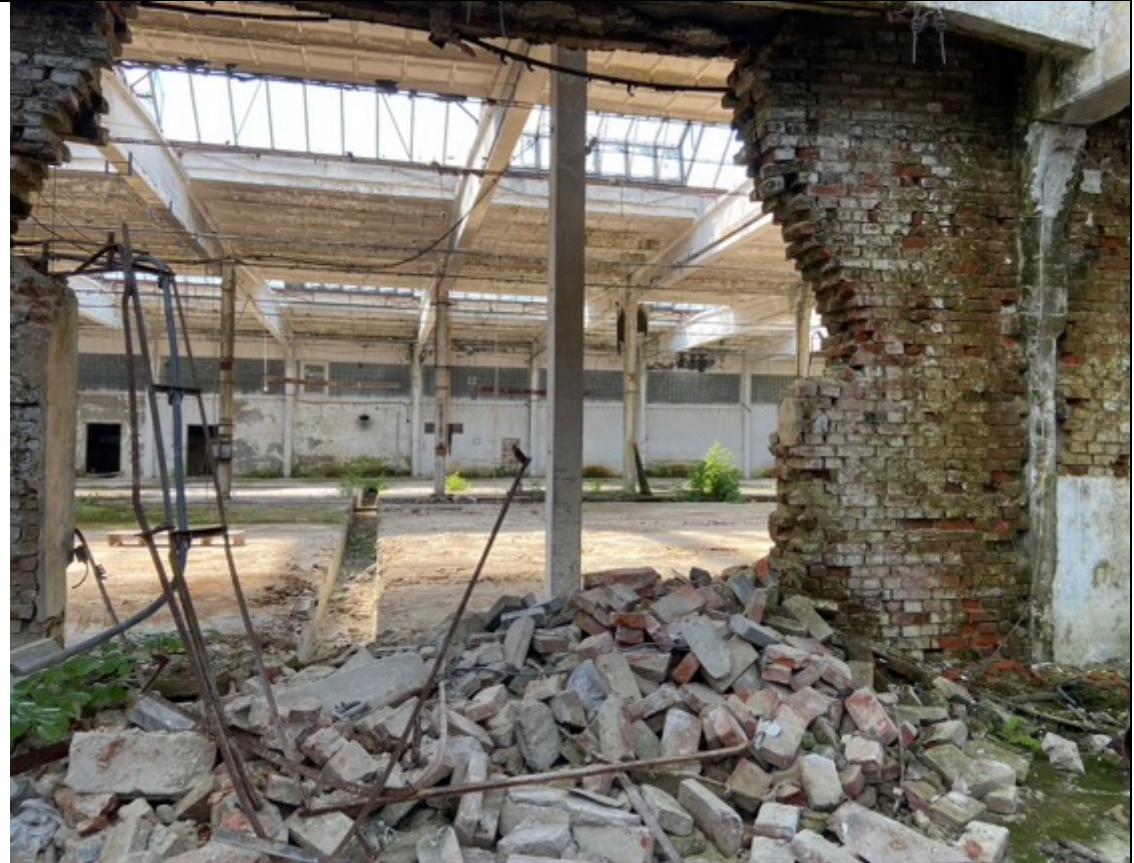
Newer hall in the south of the spinning mill, north of the administration building, transversely positioned, with two aisles in north-south direction, approx. 8 aisles in east-west direction, with slender, square pillars. The double-T-shaped, slightly gabled (prefabricated?) Concrete girders span one of the two ships in a north-south direction. The overlays on the girders consist of U-shaped elements with partially exposed reinforcing bars. In the area of the middle of the girder there is a gable hypäthral light band made of windows in steel frames, with ventilation devices. The south wall contains a light band made of 7 rows of glass bricks.

In the foreground the openwork south wall of the spinning mill: block bond, thickness approx. 45 cm (truss and stretcher), the concrete pillar walled in. Remnants of plaster and whitewash. Photo: Ivo Hammer 2021

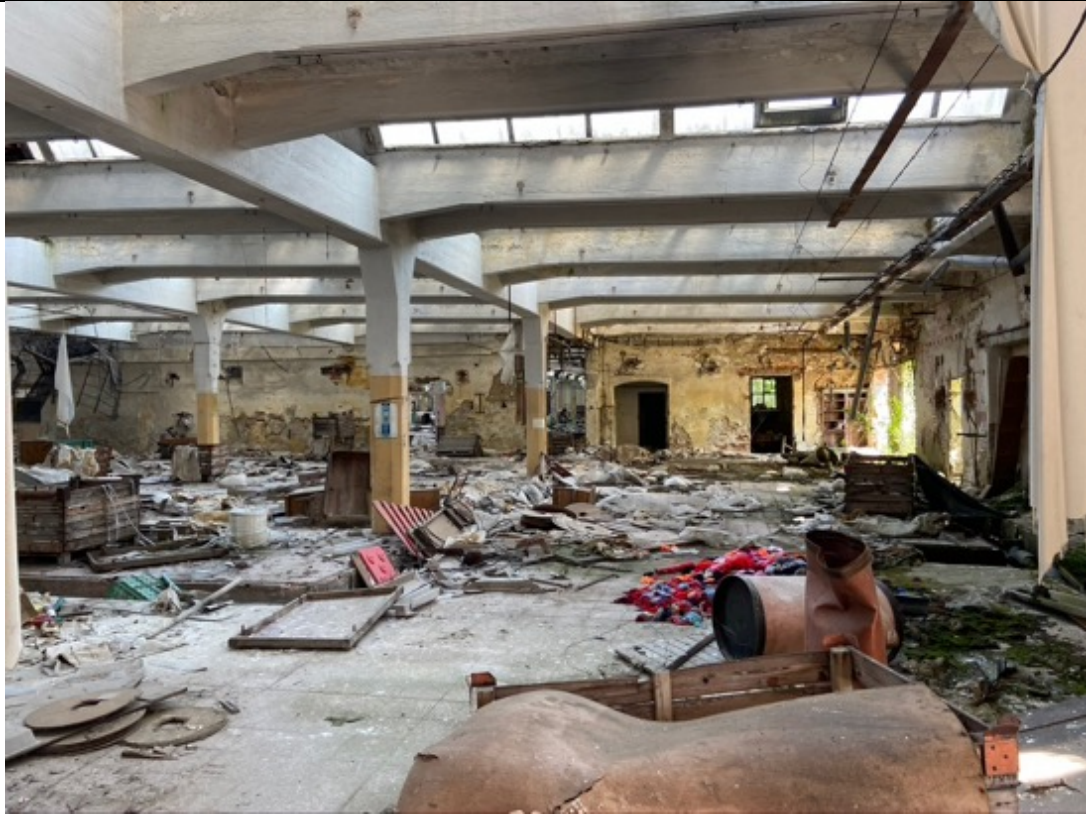
Spinning mill from approx. 1890, south interior, view to the north.

Possibly the earliest monolithic concrete structure based on the Hennebique system, patented in France in 1892 (see I. Hammer, 2021), with hypetheral lighting.

6 (?) Naves, a total of approx. 30 (?) Yokes. Floor originally perhaps red terrazzo (?). Square pillars chamfered up to a height of approx. 3 m, three yokes each are connected with a high rectangular beam. Each pillar and additionally the center of each yoke are connected with U-shaped transverse girders, each of which protrudes slightly beyond the longitudinal girder and is pulled down a bit at the point of attachment and is thus higher. The lower edges of the girders and the cross girders are chamfered up to the pillars. A gable sits on the vertical beam of the U-girder, which is completely closed with formwork concrete on the south side and a stile reinforced at the gable base on the north side in the pillar area. The ribbon windows are glazed in steel frames, 8 windows per nave, one of which (in some areas) has a ventilation device. The western and southern outer walls or the partition walls, bricked in block bond and stretcher-binder thickness with a brownish mortar (Roman cement?), Or the partition walls were plastered with a brownish mortar (possibly only one layer, which is possible with a hydraulic lime mortar), the surface probably rubbed and probably painted with a whitewash colored with fine silicate particles of sand.

The concrete parts, like the plastered brick walls, are likely to have been painted with the same yellowish-white whitewash. Photo: Ivo Hammer 2021

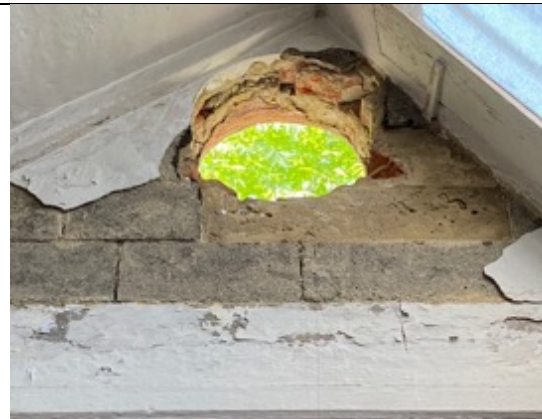
Spinning mill from approx. 1890, southern interior, western oculus of the gable wall of the hypäthral light. The inside of the gable wall is coated with panels that are black at the break edge. Possibly slag and bitumen or cement (?) Panels. The panels are probably used for thermal insulation. Photo: Ivo Hammer 2021

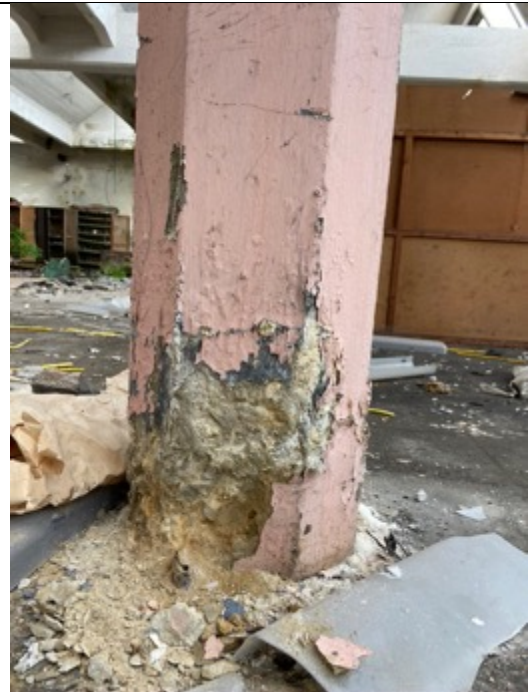
Spinning mill from approx. 1890, south interior, detail of a pillar. The cement is the brownish Roman cement. A touch up? Photo: Ivo Hammer 2021

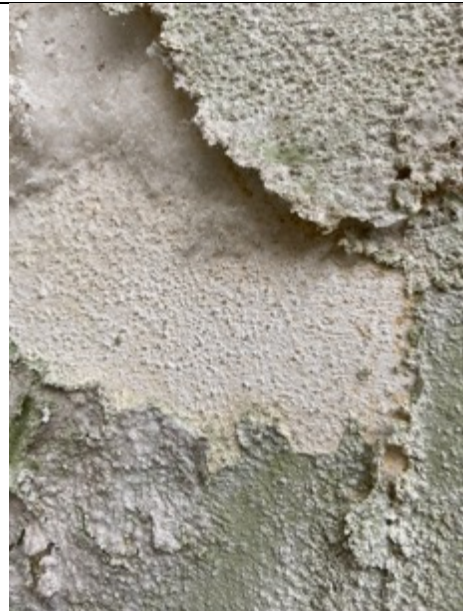
Spinning mill from approx. 1890, northern interior, detail of the west wall. Possibly original rubbed and whitewashed surface.
Photo: Ivo Hammer 2021

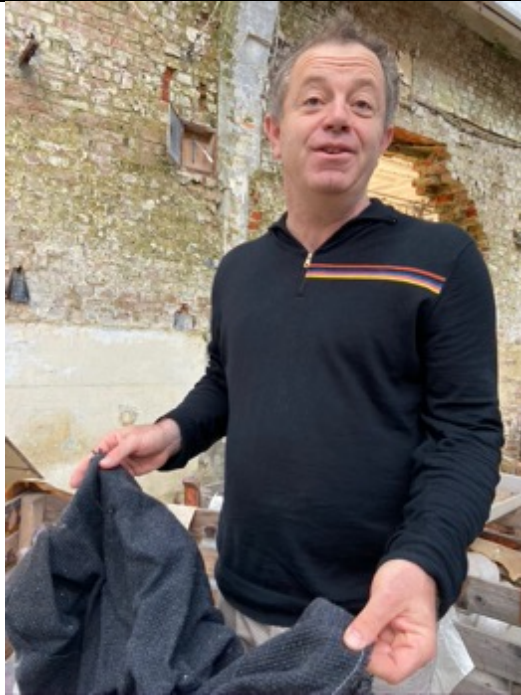
Spinning mill from approx. 1890, southern interior, devastated in 2012 (?). Daniel Low-Beer with the rest of a fabric product.
Photo: Ivo Hammer 2021

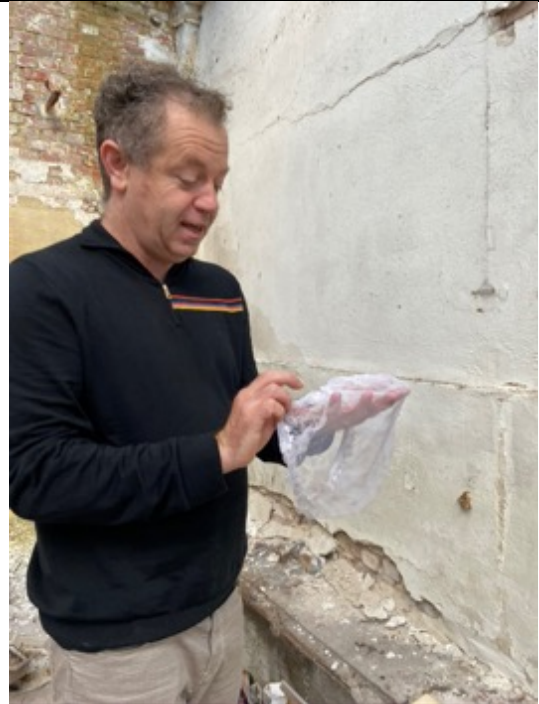
Spinning mill from approx. 1890, southern interior, devastated in 2012. Daniel Low-Beer with a textile worker's* hair protection. Photo: Ivo Hammer 2021

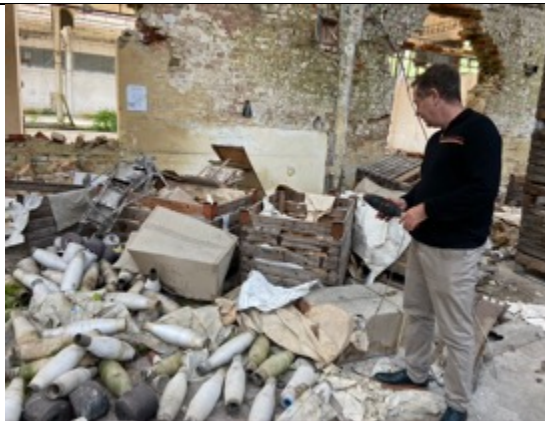
Spinning mill from approx. 1890, southern interior, devastated in 2012 (?). Daniel Low-Beer with the rest of a fabric product.
Photo: Ivo Hammer 2021

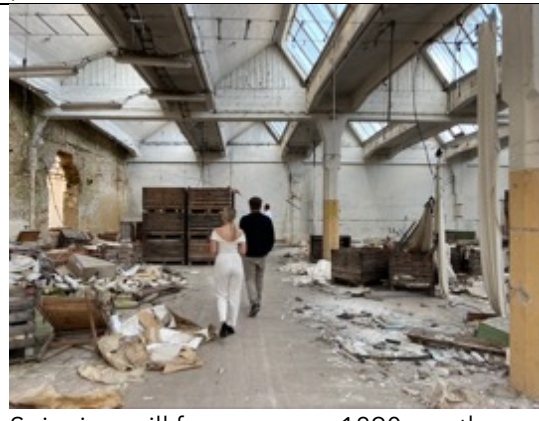
Spinning mill from approx. 1890, southern interior, devastated in 2012 (?). Photo: Ivo Hammer 2021

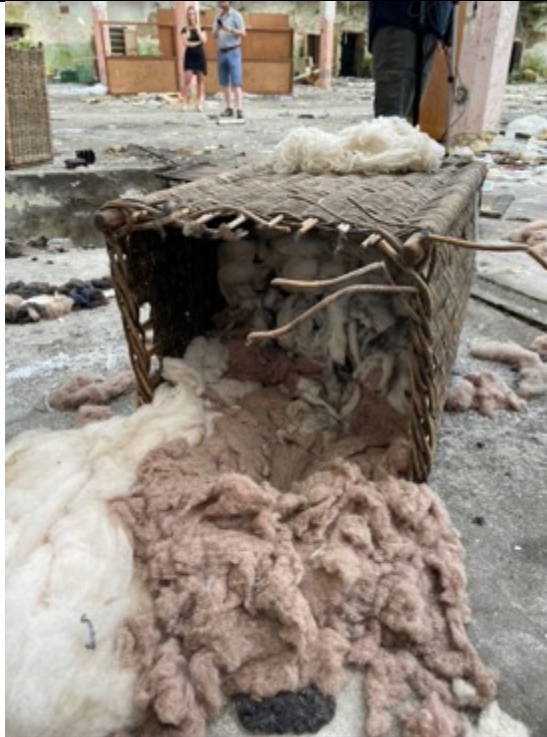
Spinning mill from around 1890, northern interior, devastated in 2012 (?). Basket with raw wool. Photo: Ivo Hammer 2021

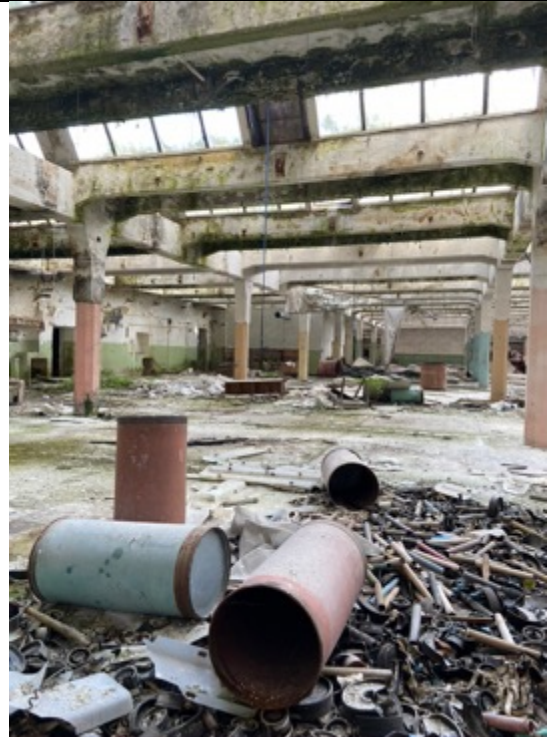
Spinning mill from approx. 1890, northern interior, devastated in 2012 (?), Remains of spinning machines. Photo: Ivo Hammer 2021

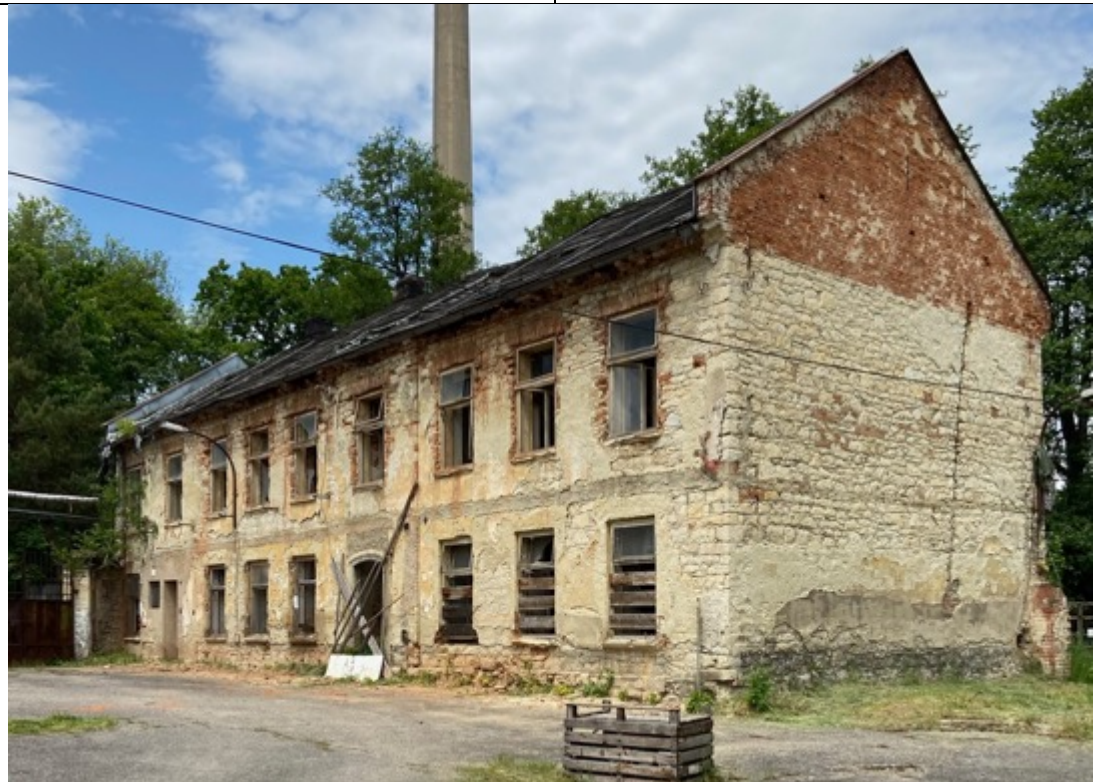
Former laboratory and workshop (SS-Bau des KZ Brnenec, German building). 2 construction phases: stone masonry mixed with bricks, 2 storeys. Gable wall built with brick. The windows on the upper floor possibly enlarged with brick, with a wedge-shaped brick lintel. Both gable walls raised. 2 chimneys in the east. Roof covered (2012?), Only the roof battens left. Completely devastated inside. Remains of plaster and whitewash preserved on the south facade. Window frames and window sashes still partially preserved. Photos: Ivo Hammer 2021

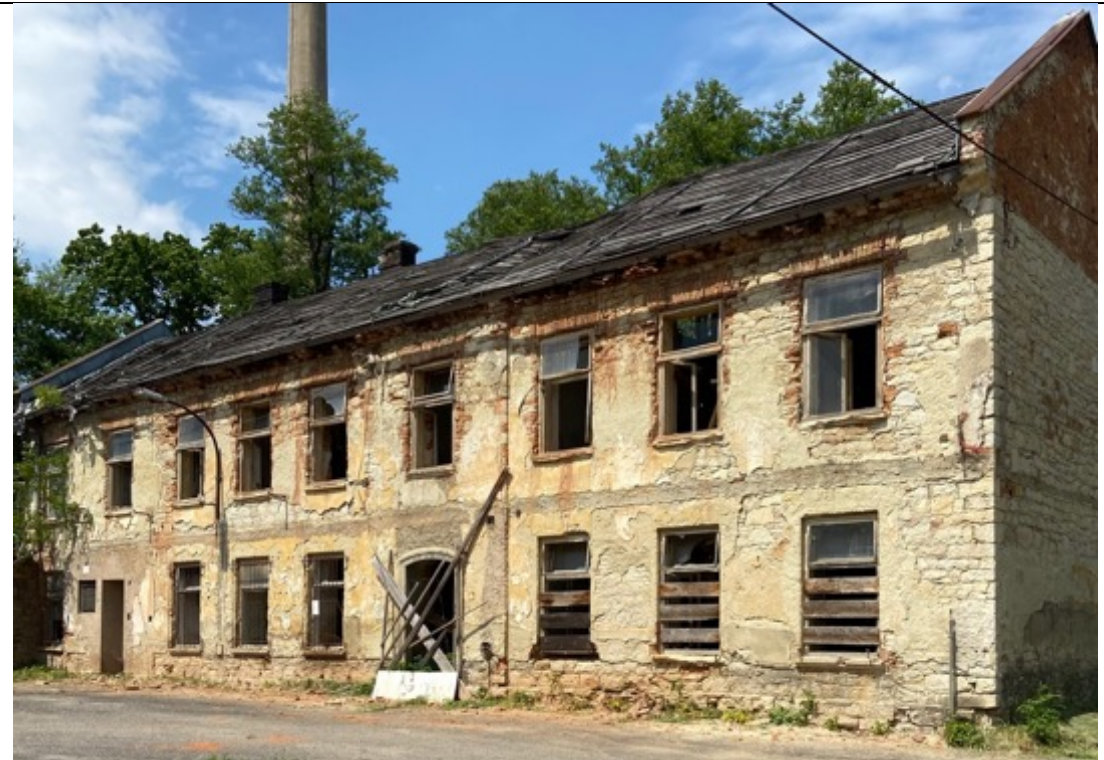
Former laboratory and workshop (SS-Bau des KZ Brnenec, German building). South facade. Profiled door frame with segmented lintel. Remnants of a tooth cut eaves.

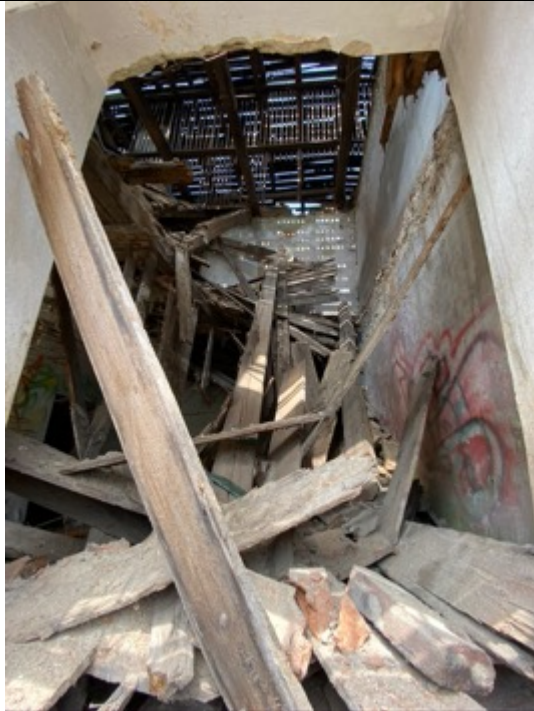
Former laboratory and workshop (SS-Bau des KZ Brnenec, German building). Look into the window to the left of the center entrance. Devastated interior. Photos: Ivo Hammer 2021

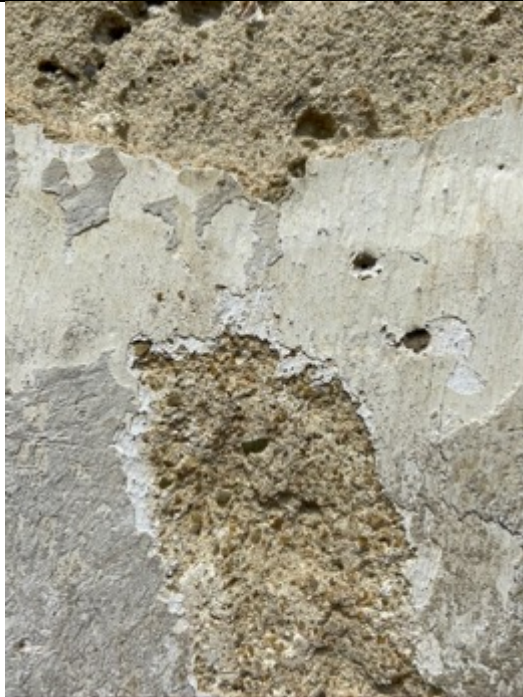
Former laboratory and workshop (SS-Bau des KZ Brnenec, German building). Details of the south facade (lower edge of the picture approx. 10 cm). Base plaster with yellowish-gray mortar with fine lime sparrows (dry slaking),

Fine plaster with the same mortar, only finer grain. Rubbed surface, very light yellowish-white, thin Freko whitewash. Approx. 5 whitewashes. Recent rub from (lime) mortar.

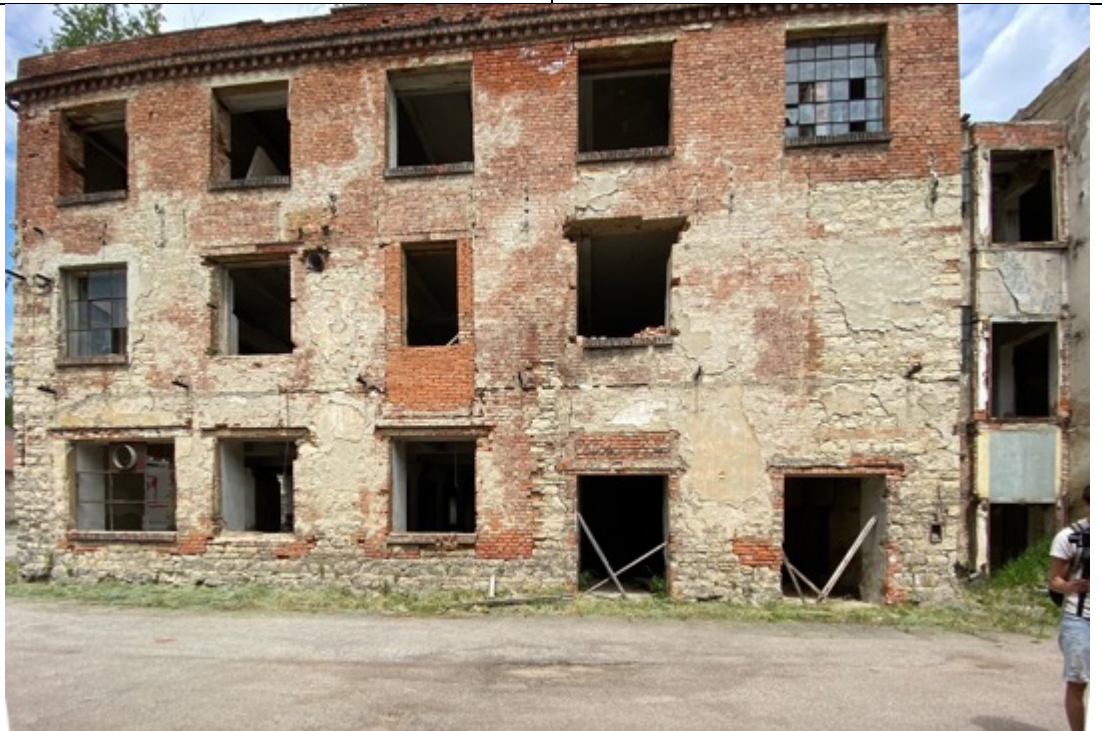
Brnec, Schindler's Ark, south facade. On the east facade, a secondary staircase is installed in the space between the adjoining building. Rebuilt several times.

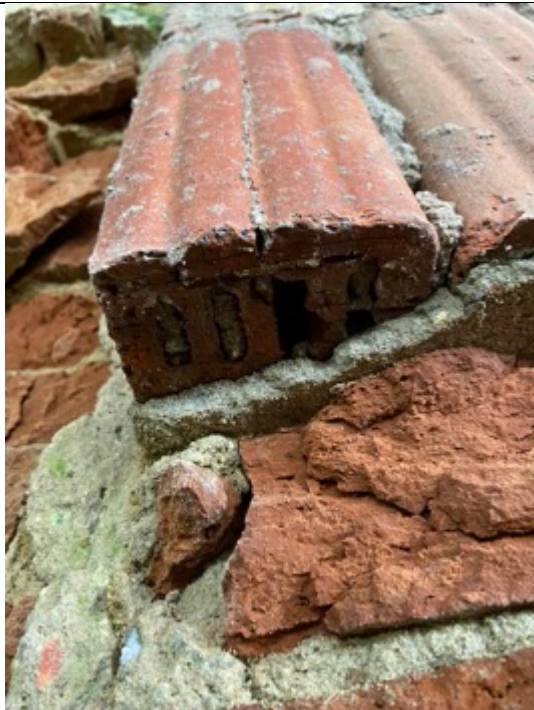
Detail of the walling up of the window

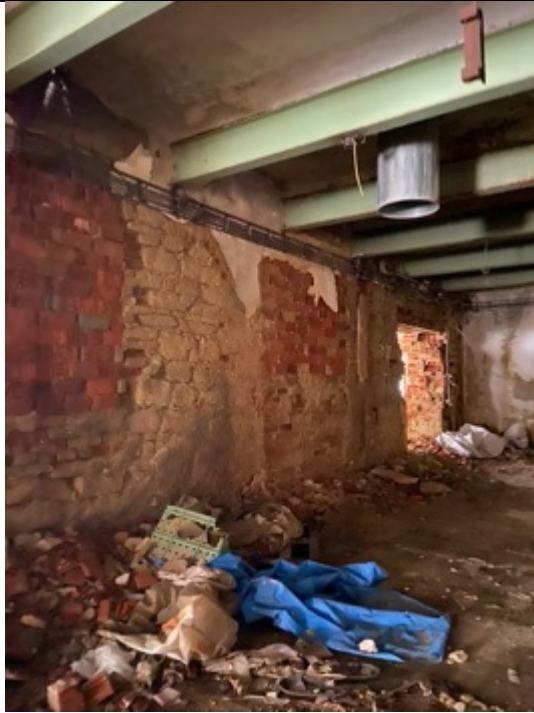
Schindler's Ark, ground floor, room east of the reinforced concrete hall. Stone masonry rebuilt with bricks.

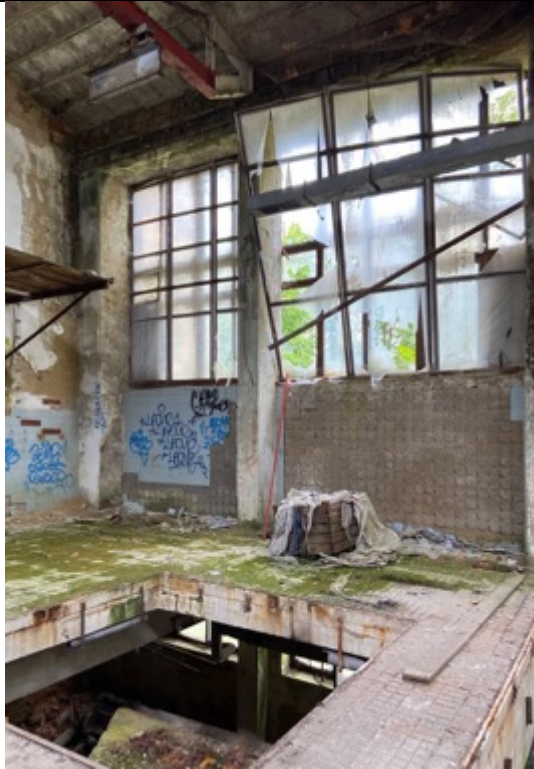
Schindler's Ark, dye works, northwest corner. Remnants of the crane

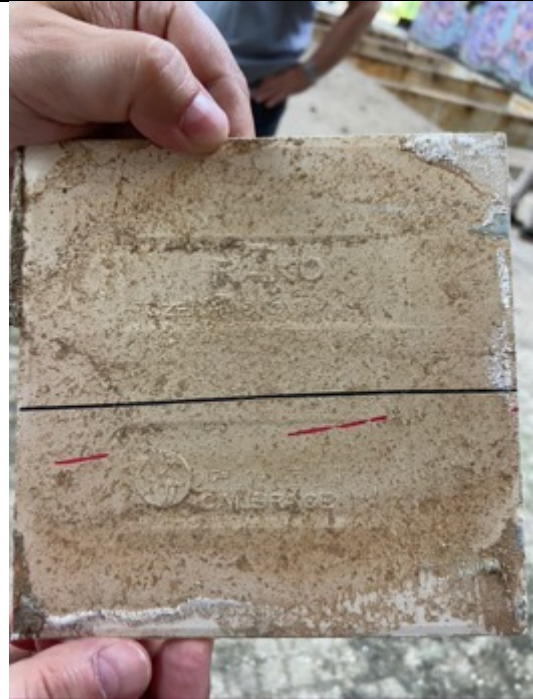
Schindler's Ark, dye works. Back of a tile:
RAKO

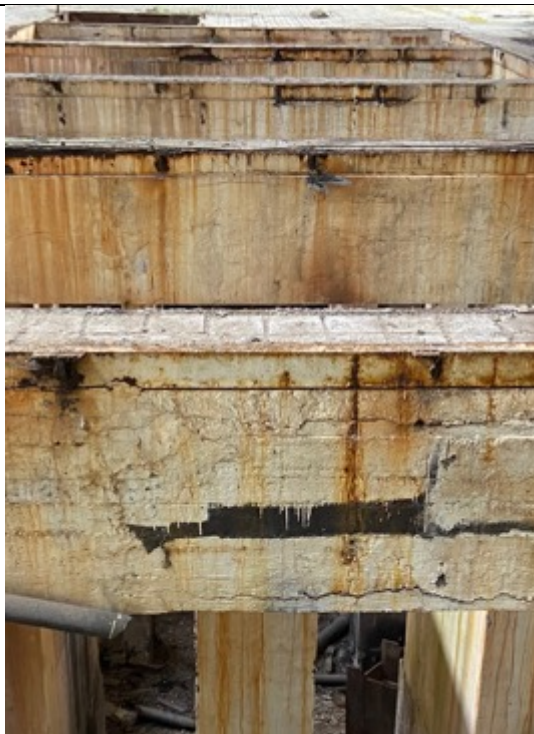
Schindler's Ark, dyeing, protective coating
(oil paint?)

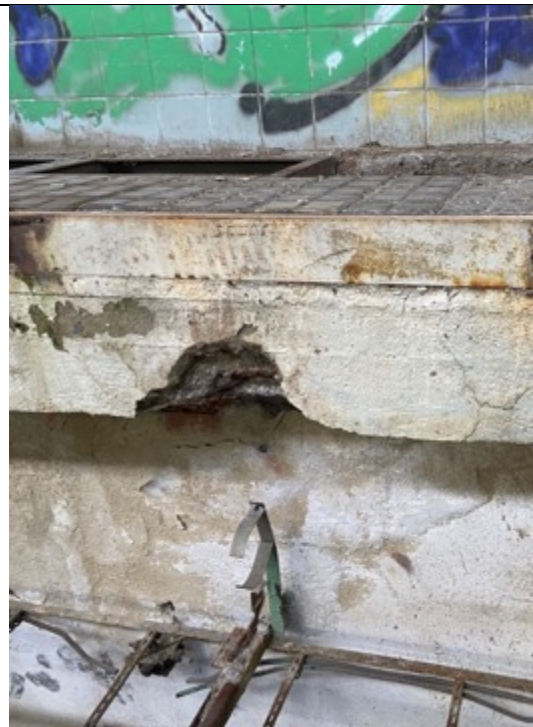
Schindler's Ark, dye works, concrete
reinforcement
